Second Five-Year Review Report  
for  
Raymark Industries, Inc. Site  
Stratford, Connecticut

September 2005

The United States Environmental Protection Agency  
Region 1, New England  
Boston, Massachusetts

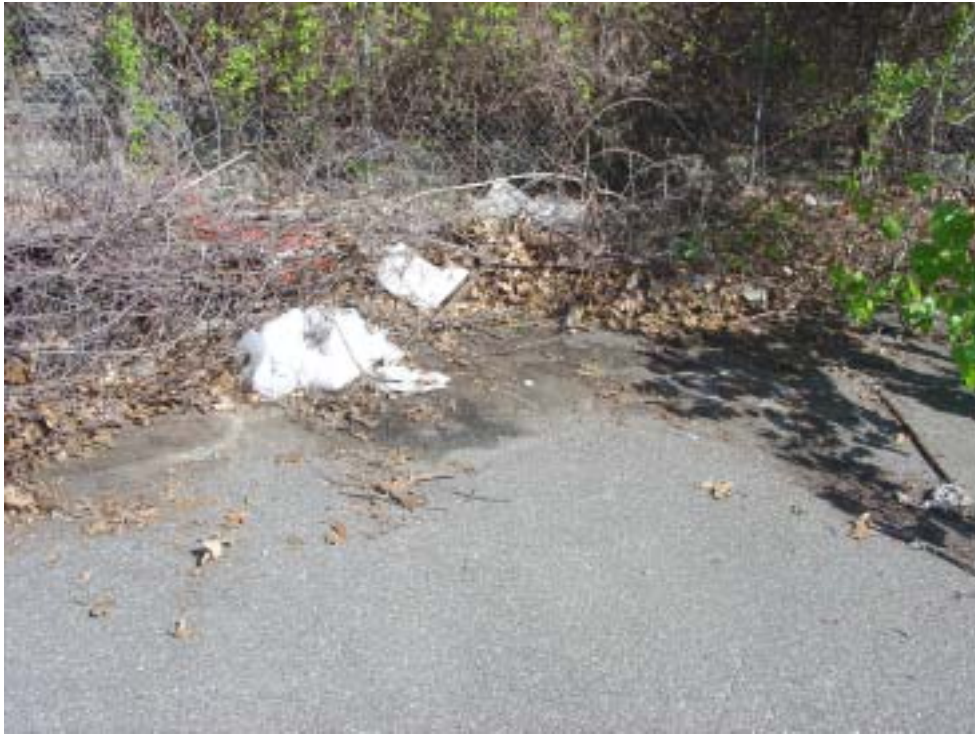
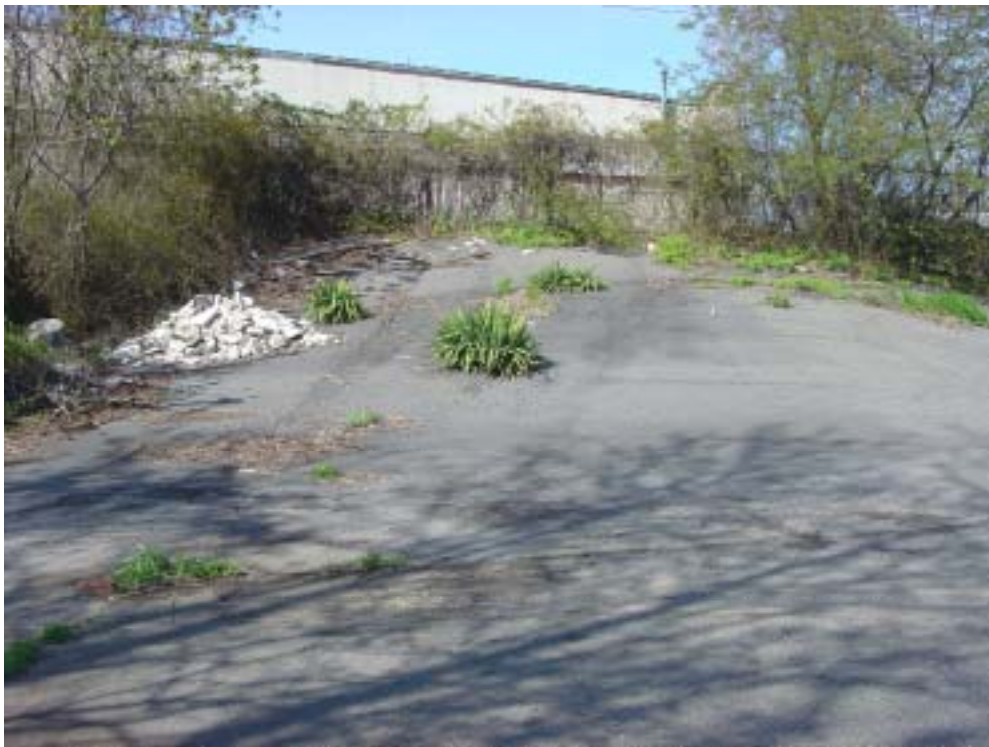
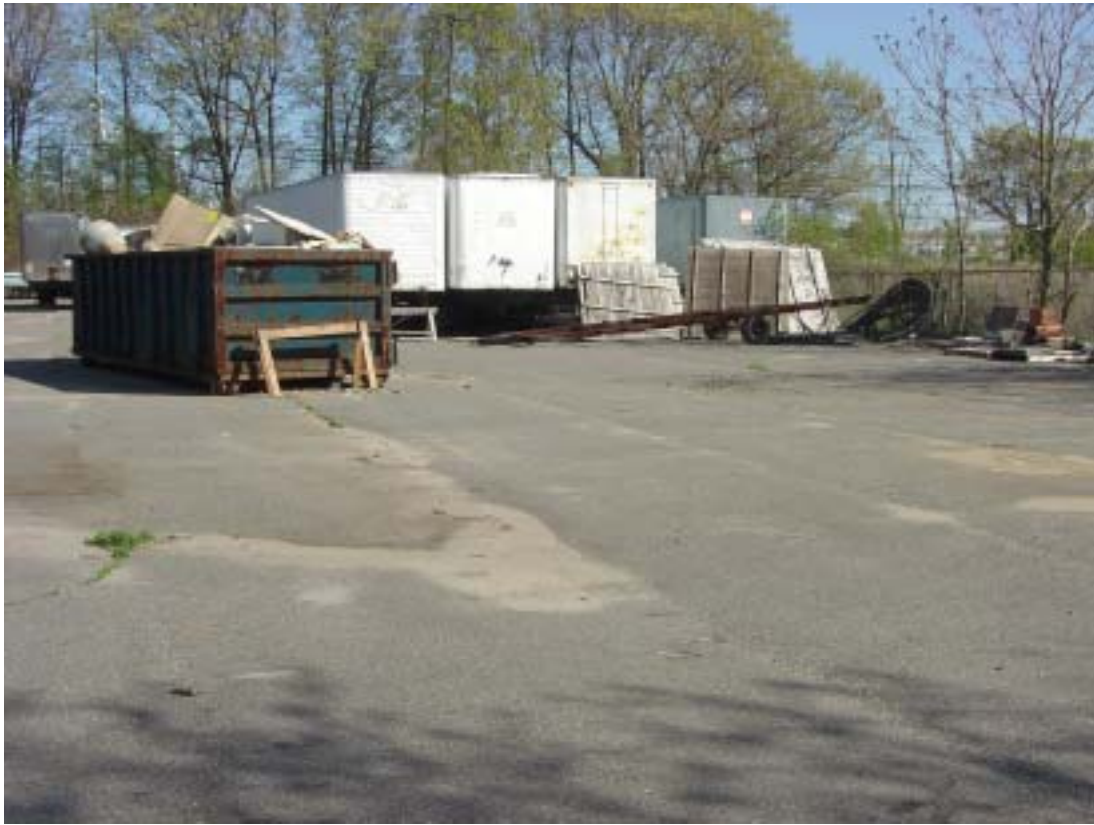
The paved parking area is used for storage of construction materials and supplies including trailers and bulk materials. The pavement is degraded and cracked with vegetation growing through. Next 2 pictures.

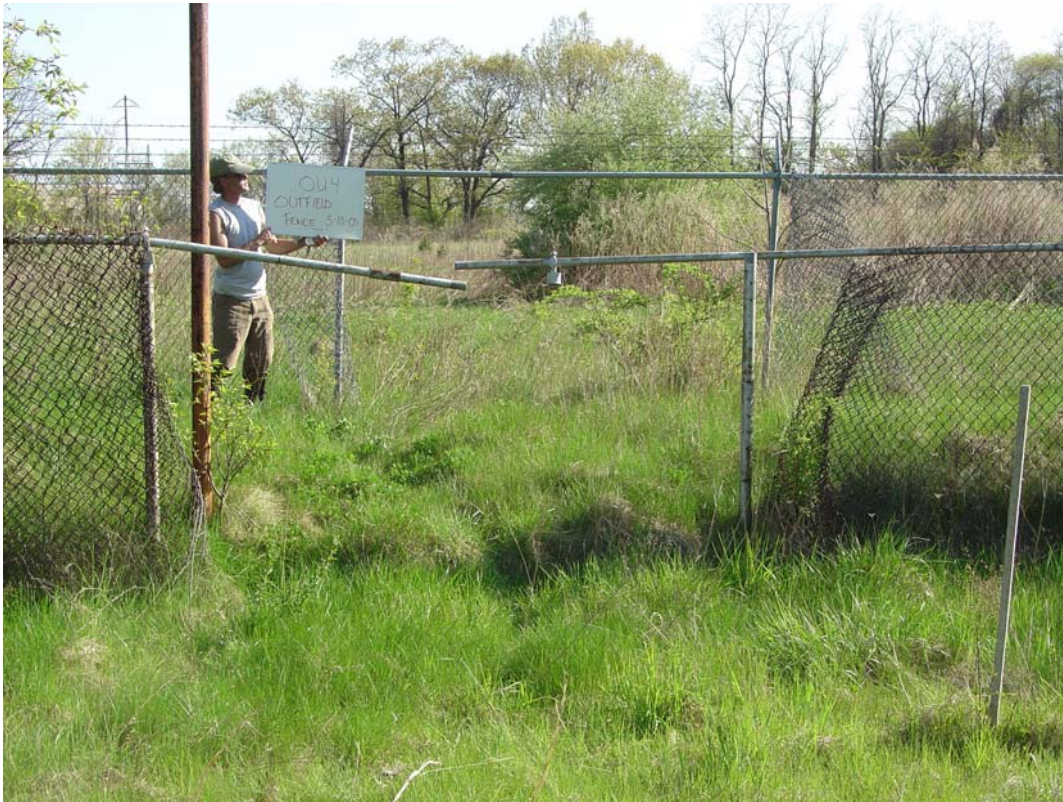
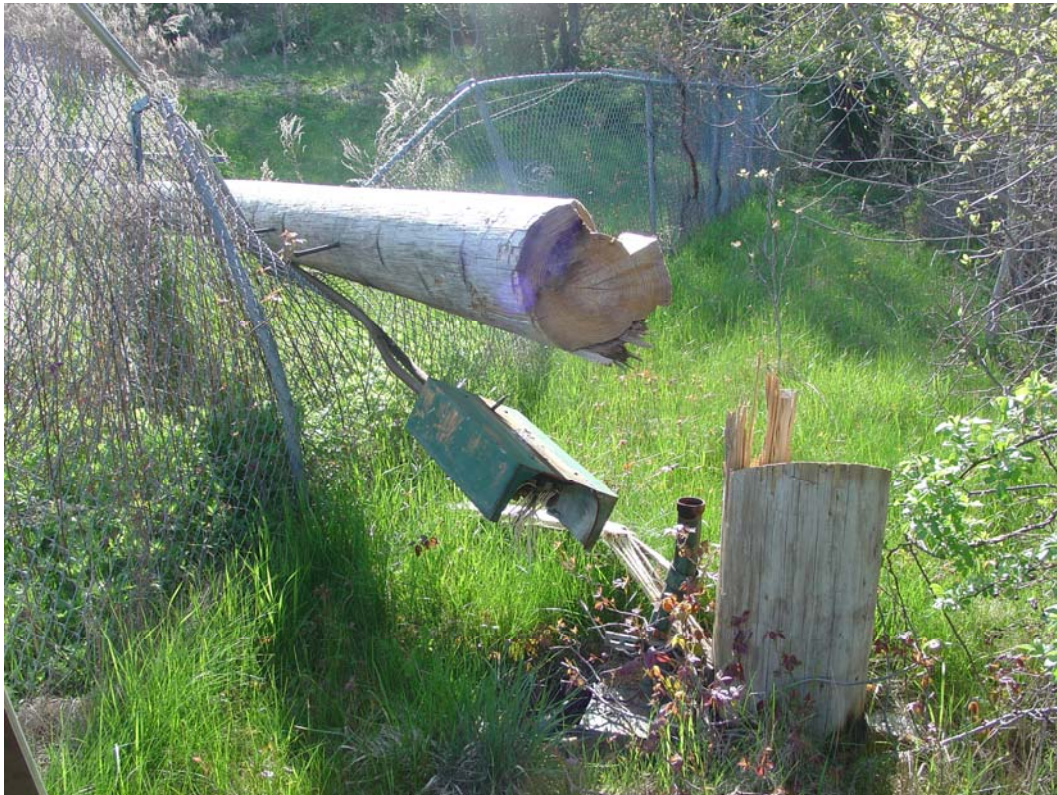
A breach in the two right outfield fences was used to leave the ball field and inspect the open field south of the ball diamond. This breach was originally made during earlier field investigations but had been repaired in the fall of 1998. For unknown reasons, a large wooden utility pole/light stand in between the two outfield fences in this area has been cut down by some one using a chainsaw, this pole fell onto one of the fence sections damaging it; however, it is unclear why the fence breach was made. Next 2 pictures.

1. The fence erected by EPA during removal actions in 1993/1994 has been deliberately cut to provide access between the ballfield and the abutting Contract Plating property. This fence should be repaired to prevent trespassing on the ballfield.

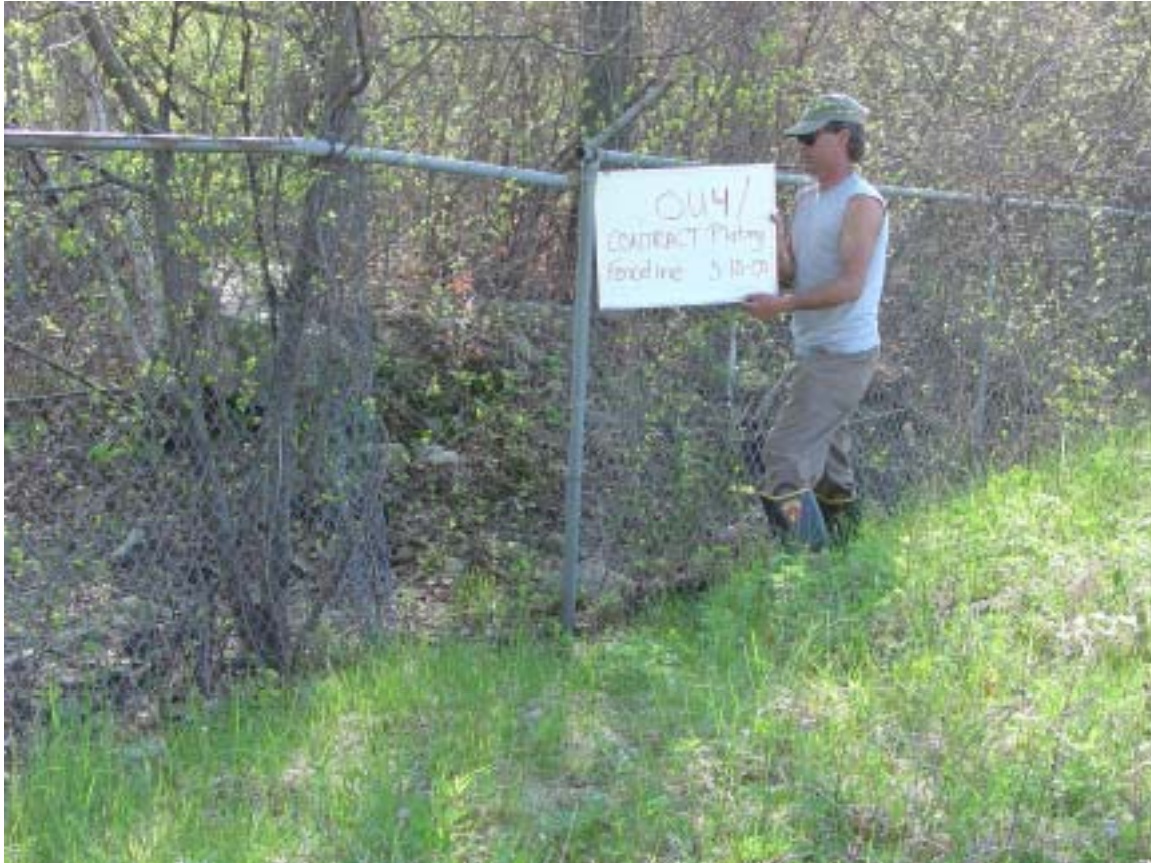
Multiple breaches in the perimeter fence between OU4 and Contract Plating were noted and numbered sequentially as found. Many of these breaches appear to coincide with locations where the fence had been cut and repaired during the RI/FS test pitting activity. Breach number 1 is located approx. 100 feet from the south corner of the fence.

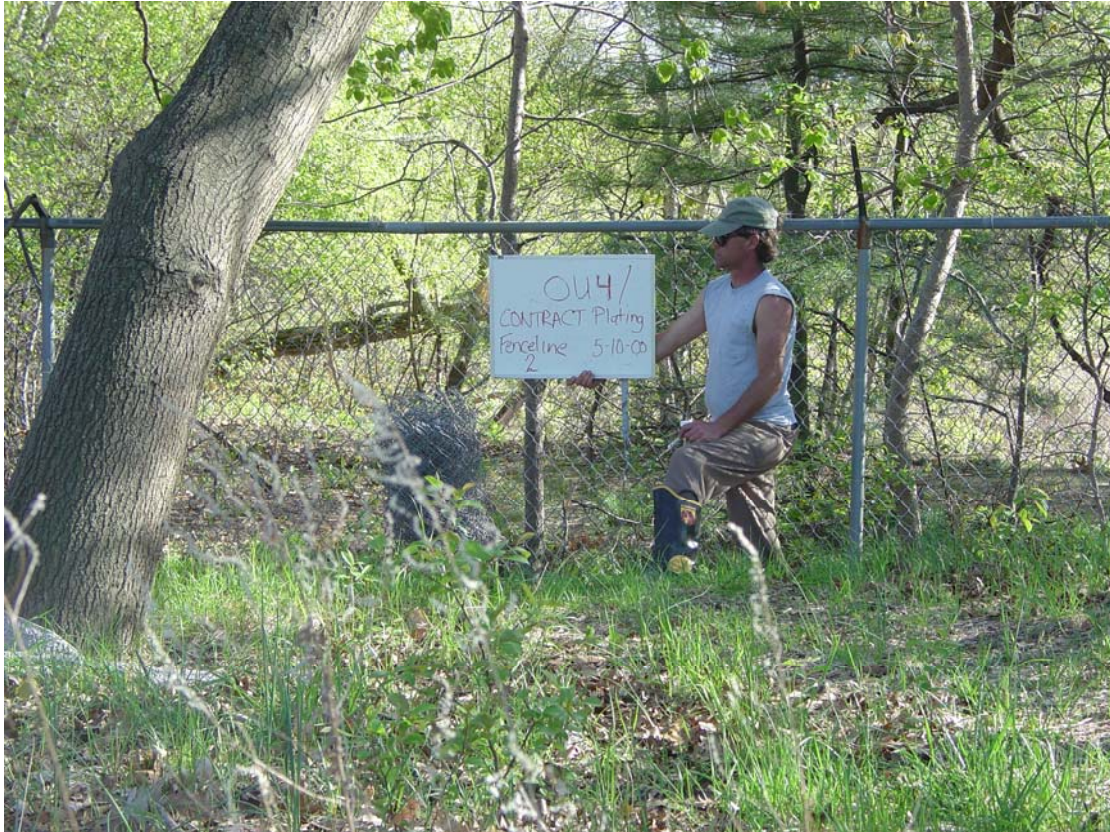
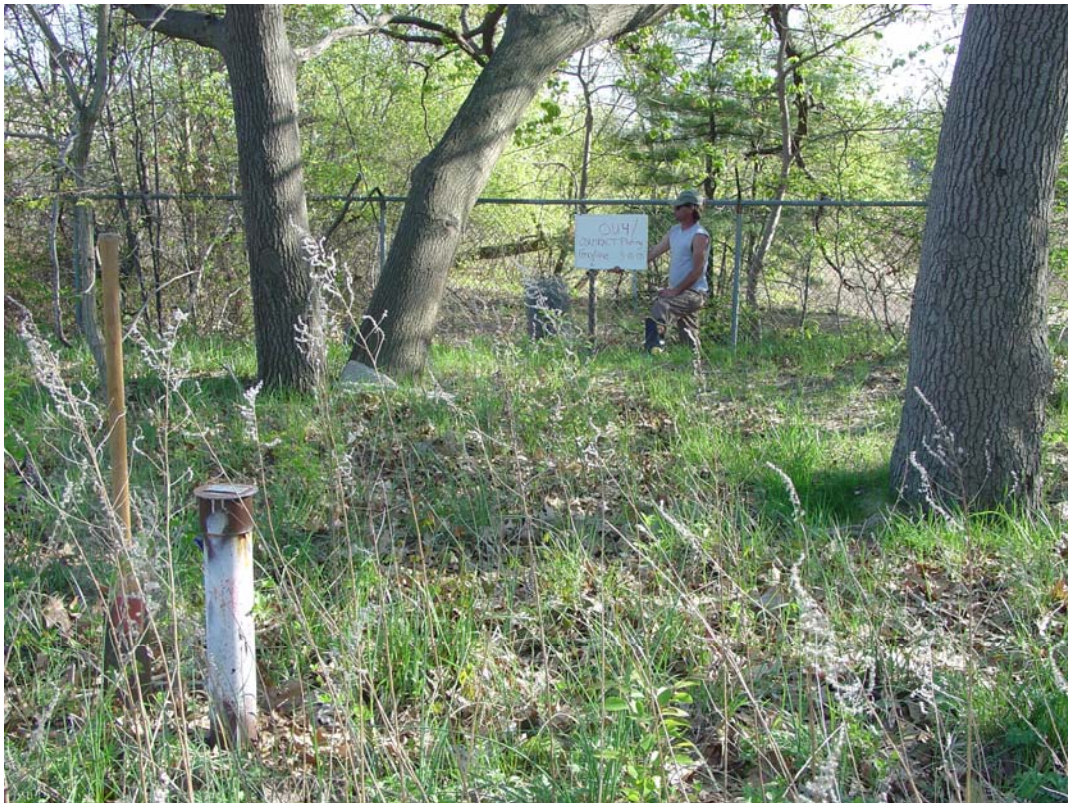
The second breach is still partially wired together, located near the MW-401 well cluster. Next 2 photos.

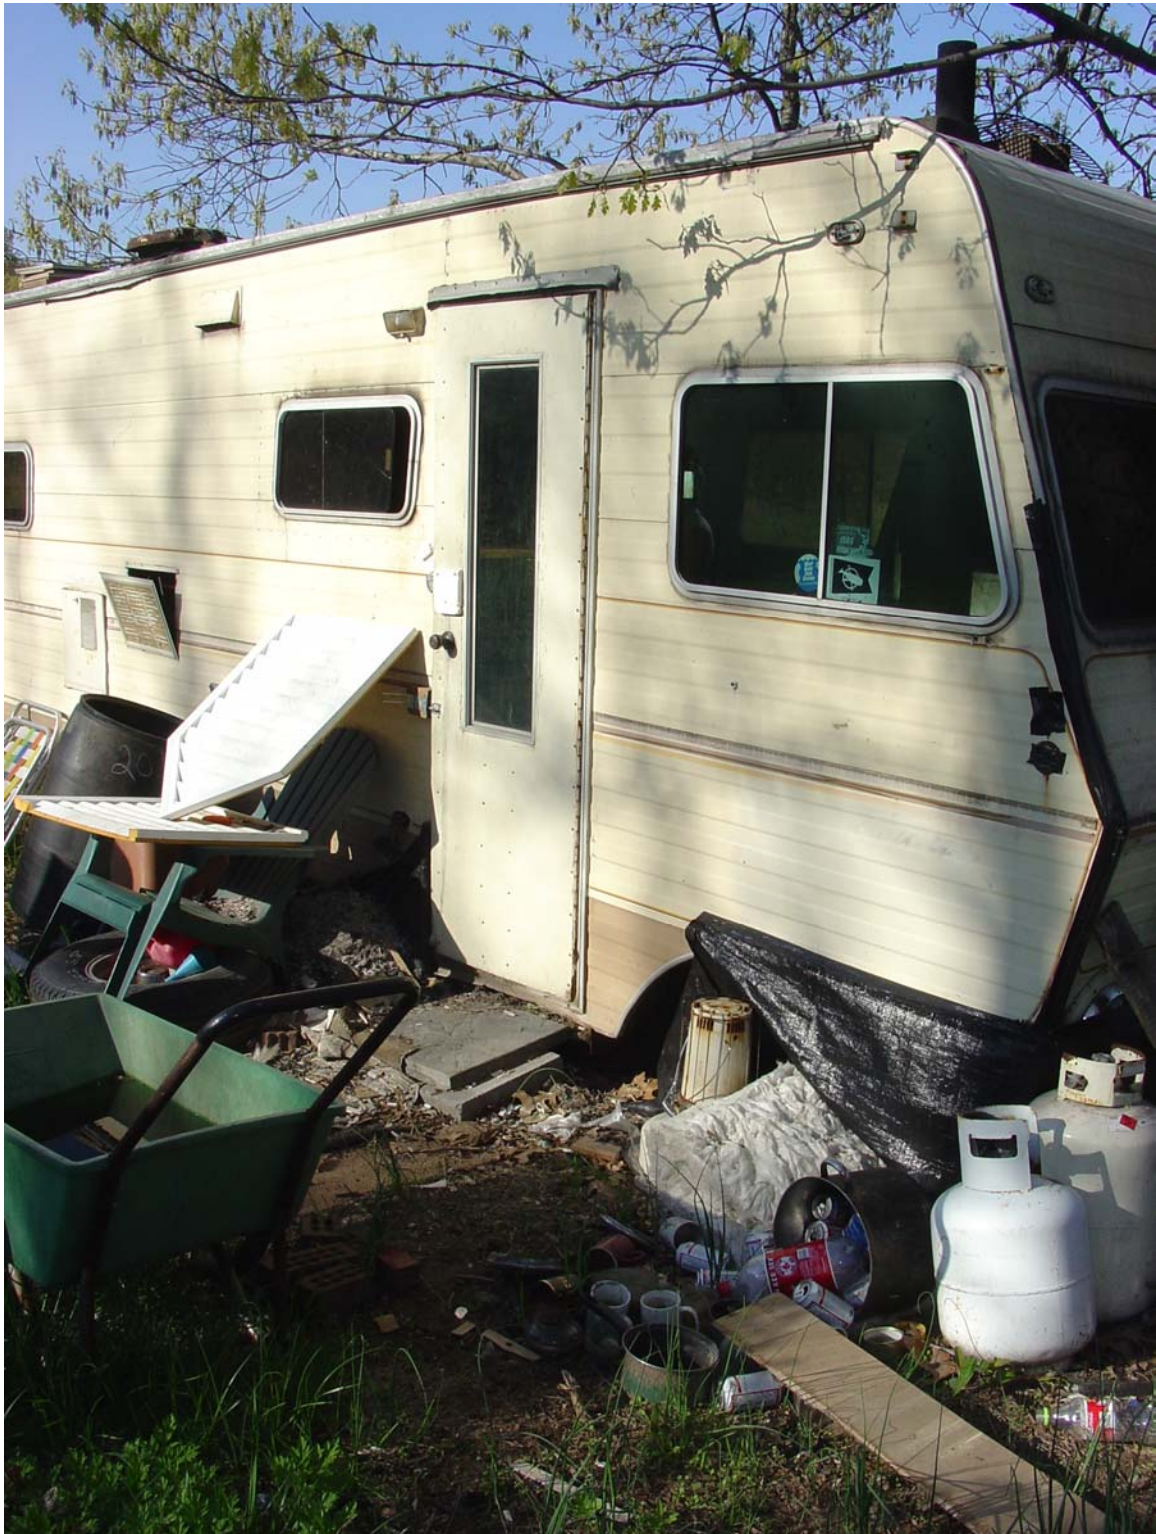
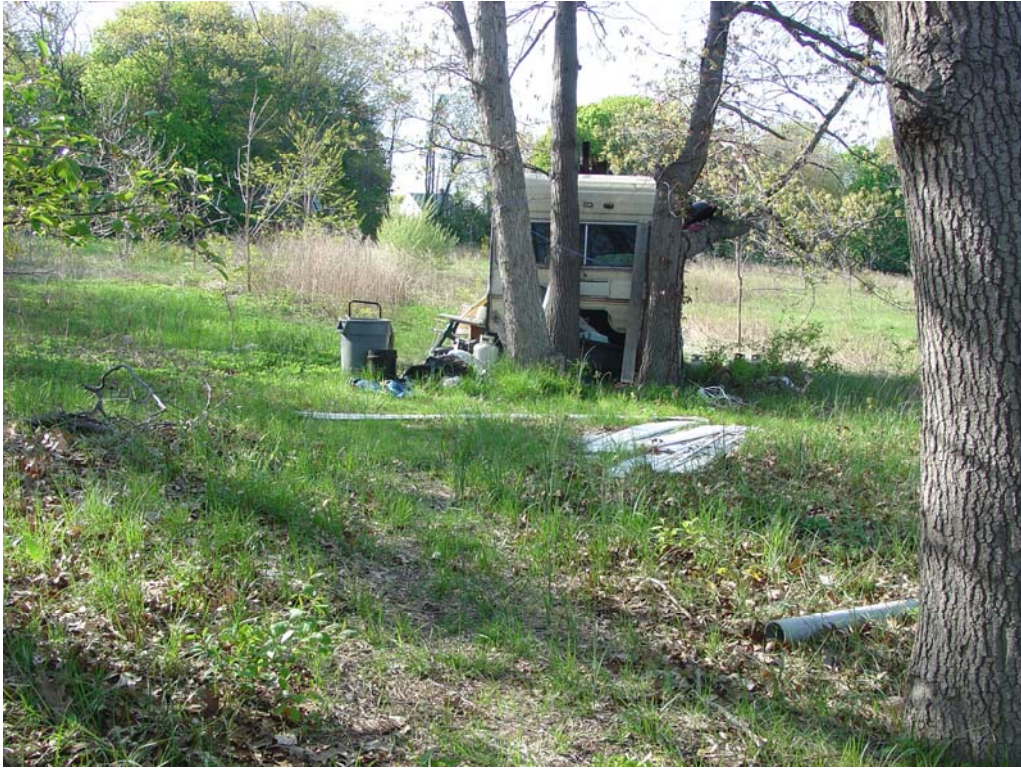
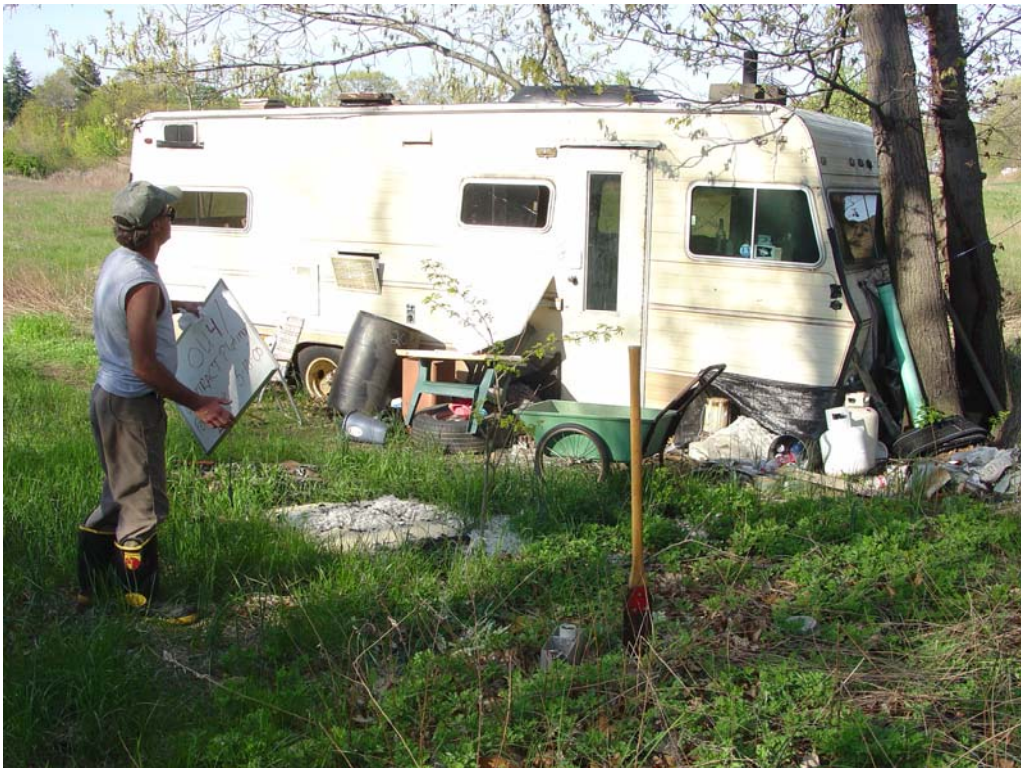
Between breach number 2 and 3, we encountered the mobile home parked in the wooded area between MW-401 and MW-2. The mobile home is surrounded by garbage and debris including plywood, empty beer cans & liquor bottles, cat-food cans, old clothes, propane bottles and a kerosene heater. There is a heavily worn footpath leading to the mobile home from the gate to the parking area as discussed earlier. See next 3 photos.

In the photo above, monitoring well MW-2 can be seen near the bottom just to the left of the wood-handled brush axe we stuck in the ground as a marker. The well was not opened, but the protective casing hasp is broken so that the well is available for access. The condition of the well was not determined, nor was the repair of protective casing made. We did return the protective casing lid back to the closed position.

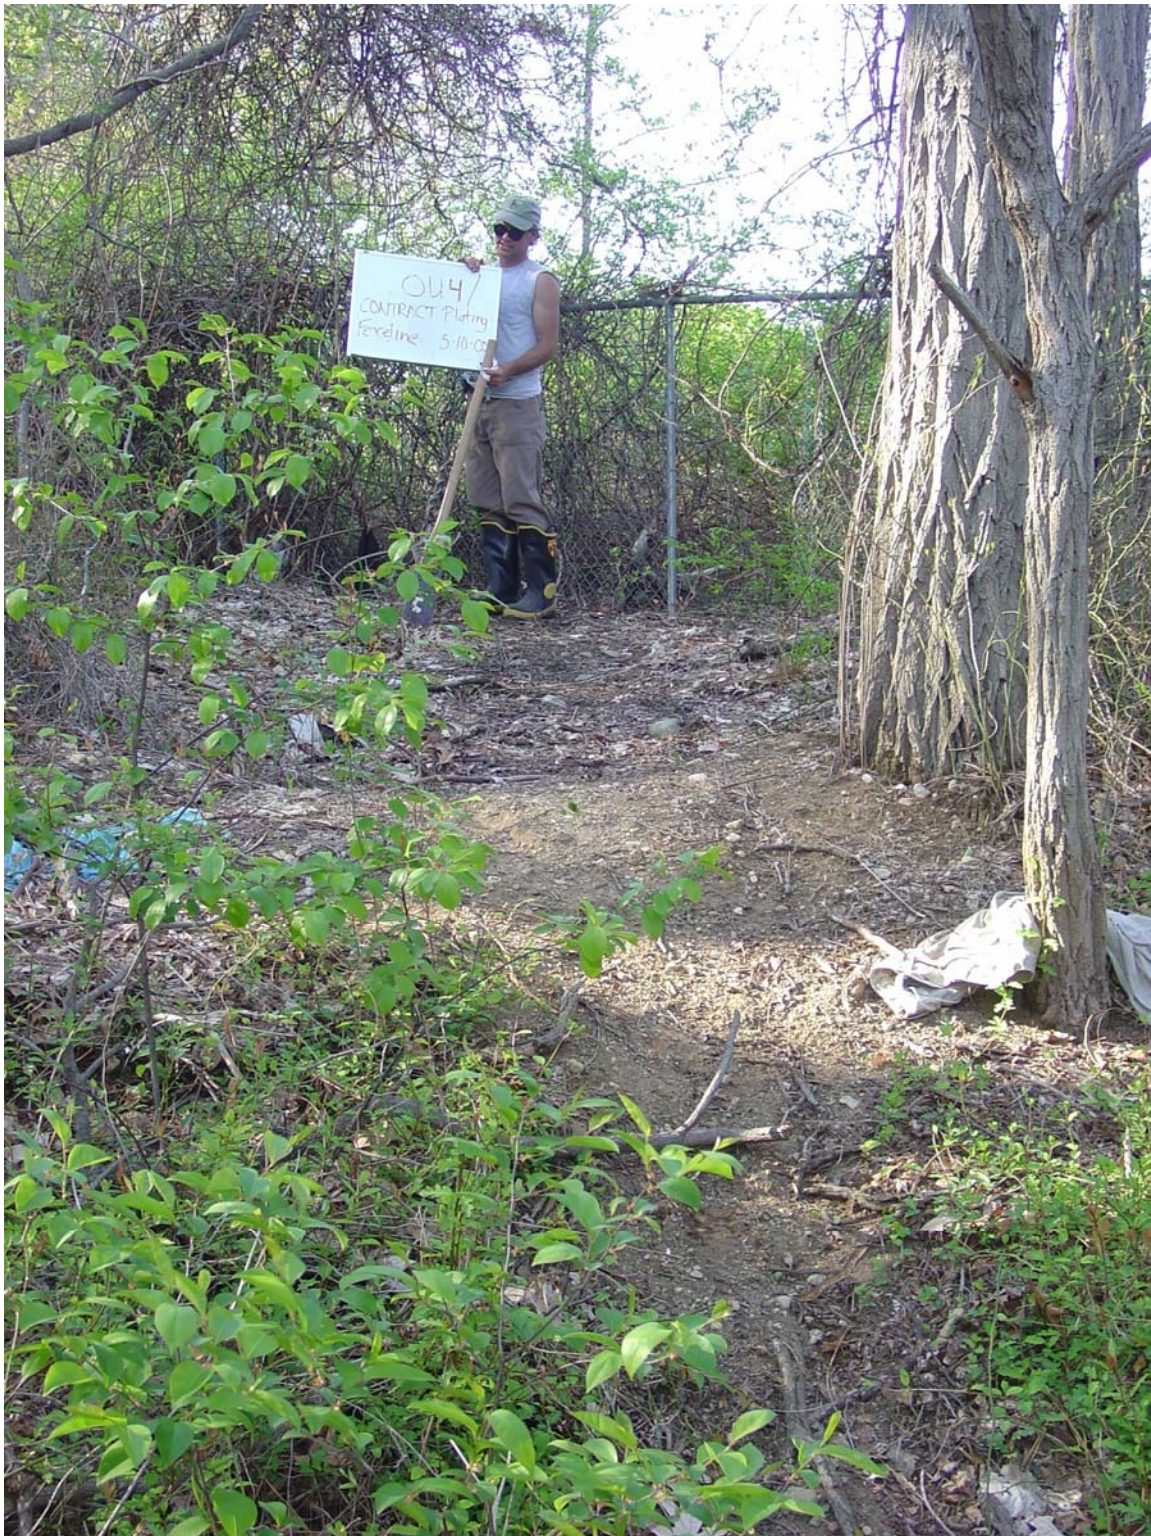
Breach number 3 in the perimeter fence may coincide with the cut made to conduct Test Pit 15 during the RI/FS. This cut had been repaired but appears to get frequent used based on the wear path especially on the Contract Plating side. This photo was taken from the Contract Plating property and the wear path is visible at the bottom of the photo.

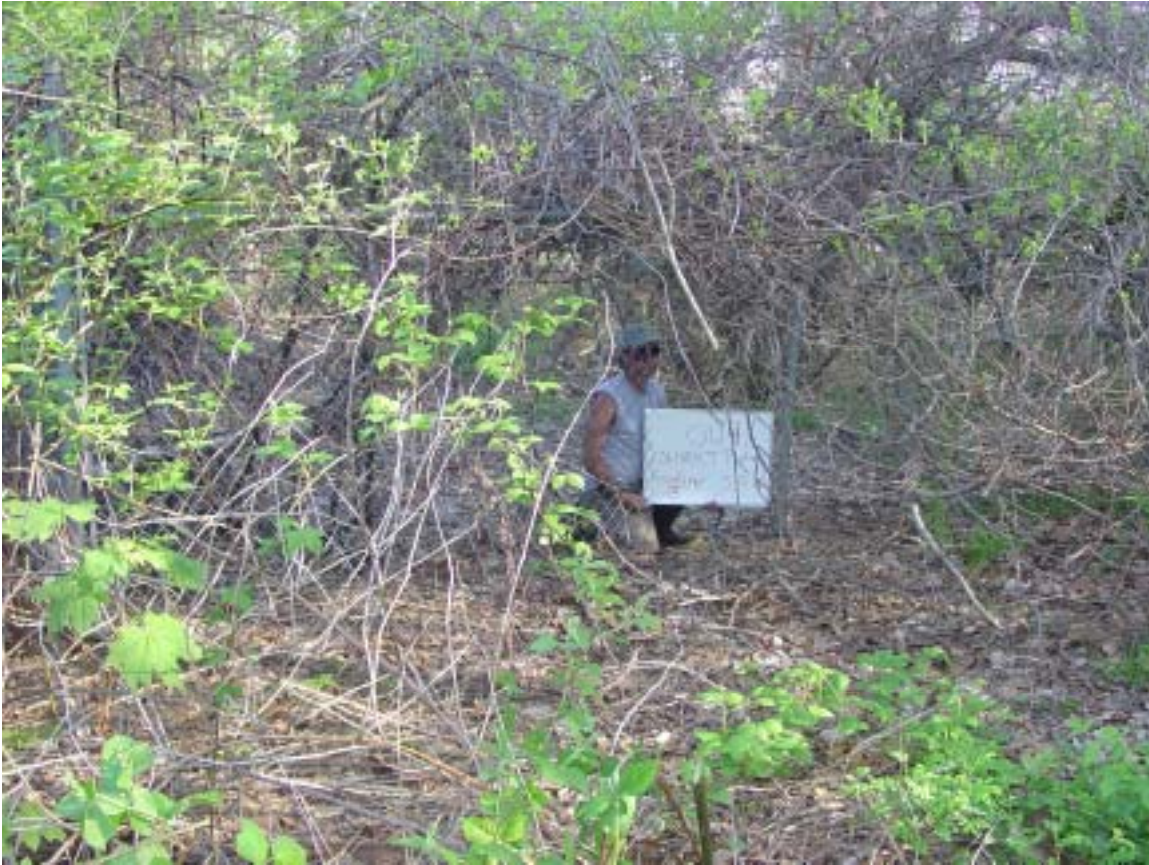
Breach number 4 is different from the others in that they are complete vertical cuts through the chain-link fence, while breach 4 is a 2.5 foot by 2.5 foot square of fence removed from the base of the fence near a corner. This breach also has a wear path but was more camouflaged than the others.

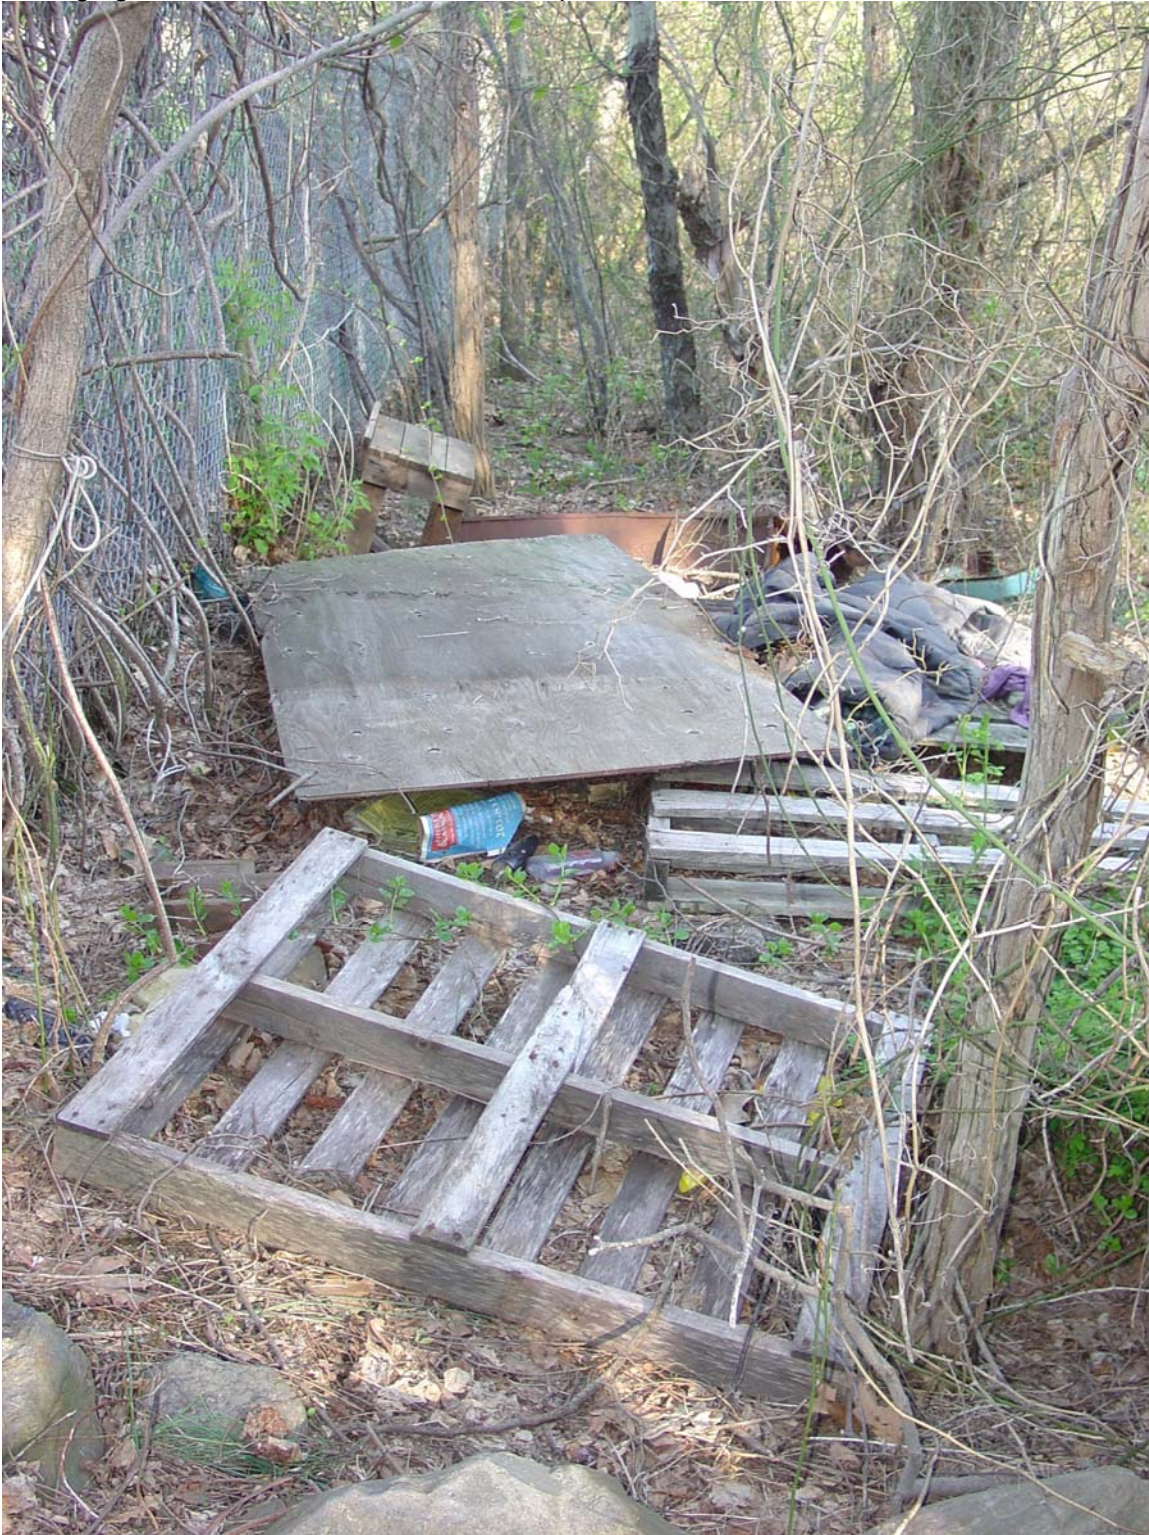
A possible shelter/hangout for a homeless person was located approx. 50 feet from the corner near breach 3 and 4 on the Contract Plating side of the fence. Wooden pallets, plywood, an old sleeping bag and used food containers were scattered on the ground. Clothing and a machete were hanging from branches and a canteen cup was visible.

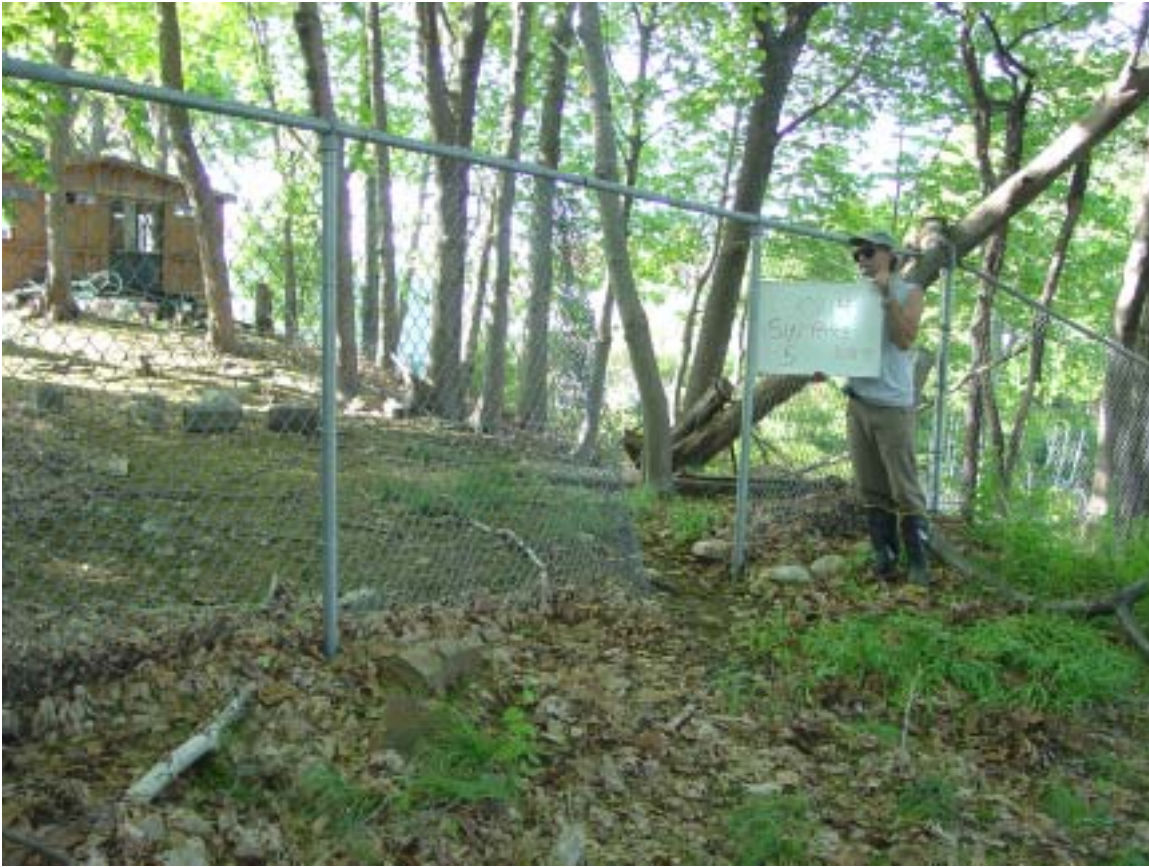
Breach number 5 is located approx. 80 feet from the fence corner near Test Pit 16. This breach connects the OU4 site to the backyard of #60 Clinton Ave. It appears that this resident may have been dumping yard waste and other debris including old fence/pallets in the area.

5. A break in the fence from a Clinton Avenue residence should be repaired and disposal of yard waste and other trash should be stopped. Residents should be informed that Raymark waste is visible on the surface.

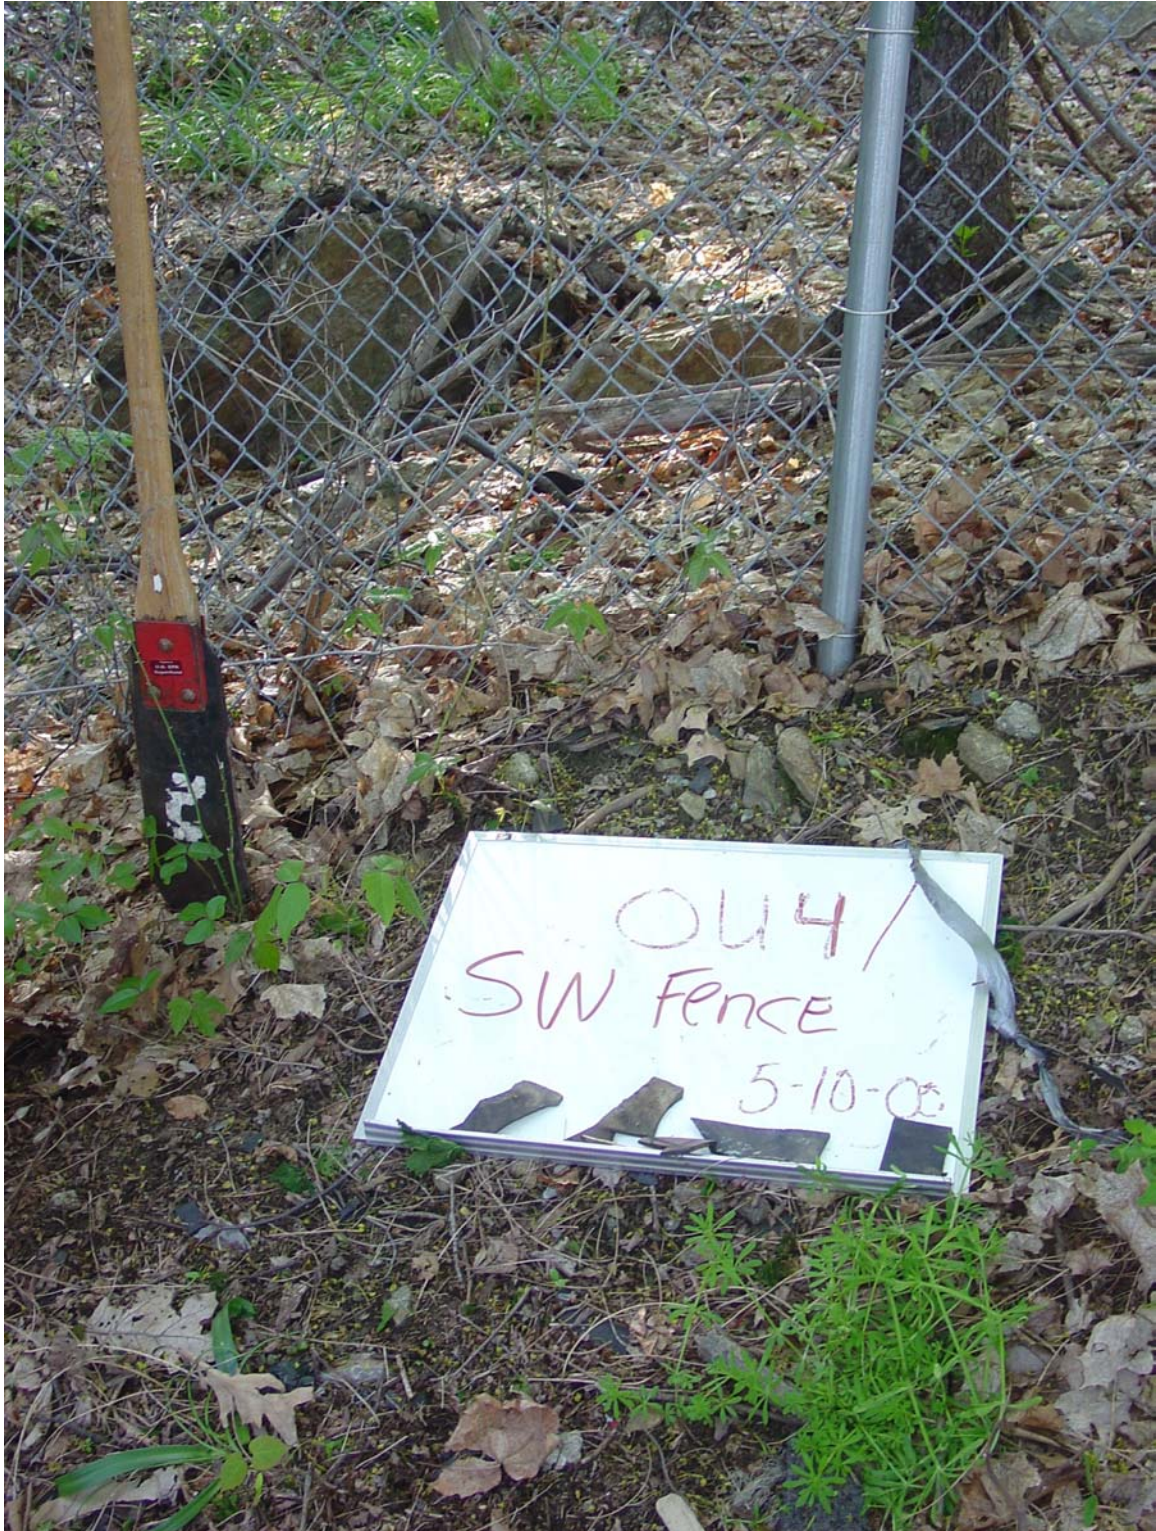
An area located between breach 5 and the corner of the fence was found to have brake pads/clutch plates at the ground surface near a fence post.

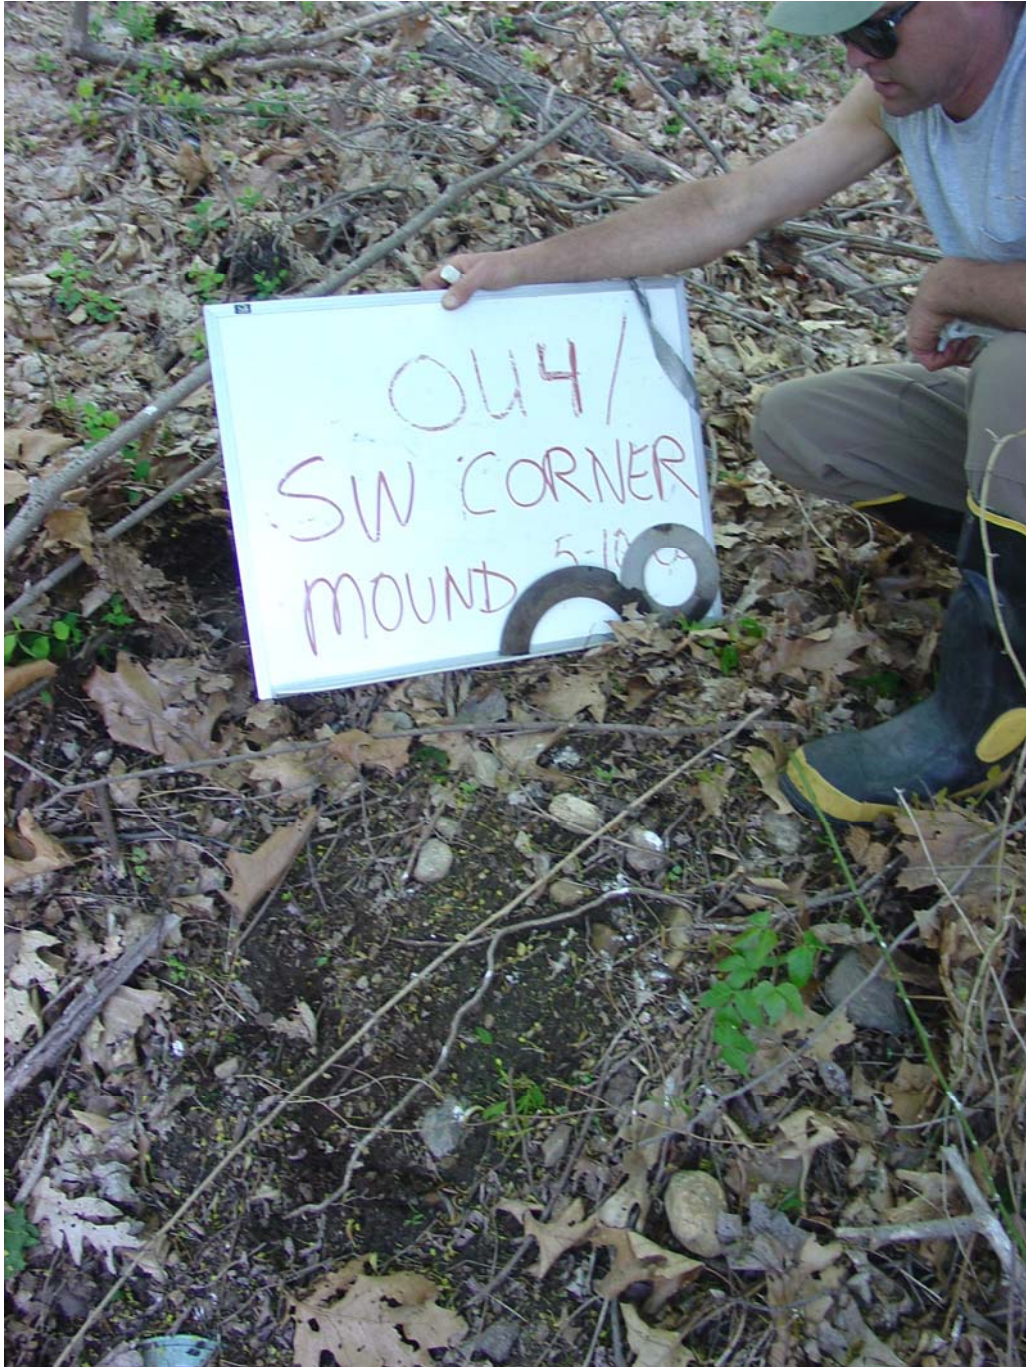
Upon further investigation, additional Raymark type waste/fill was noted exposed at the ground surface, especially along the steep slope leading out of the woodline east of #50 & 60 Clinton Ave.

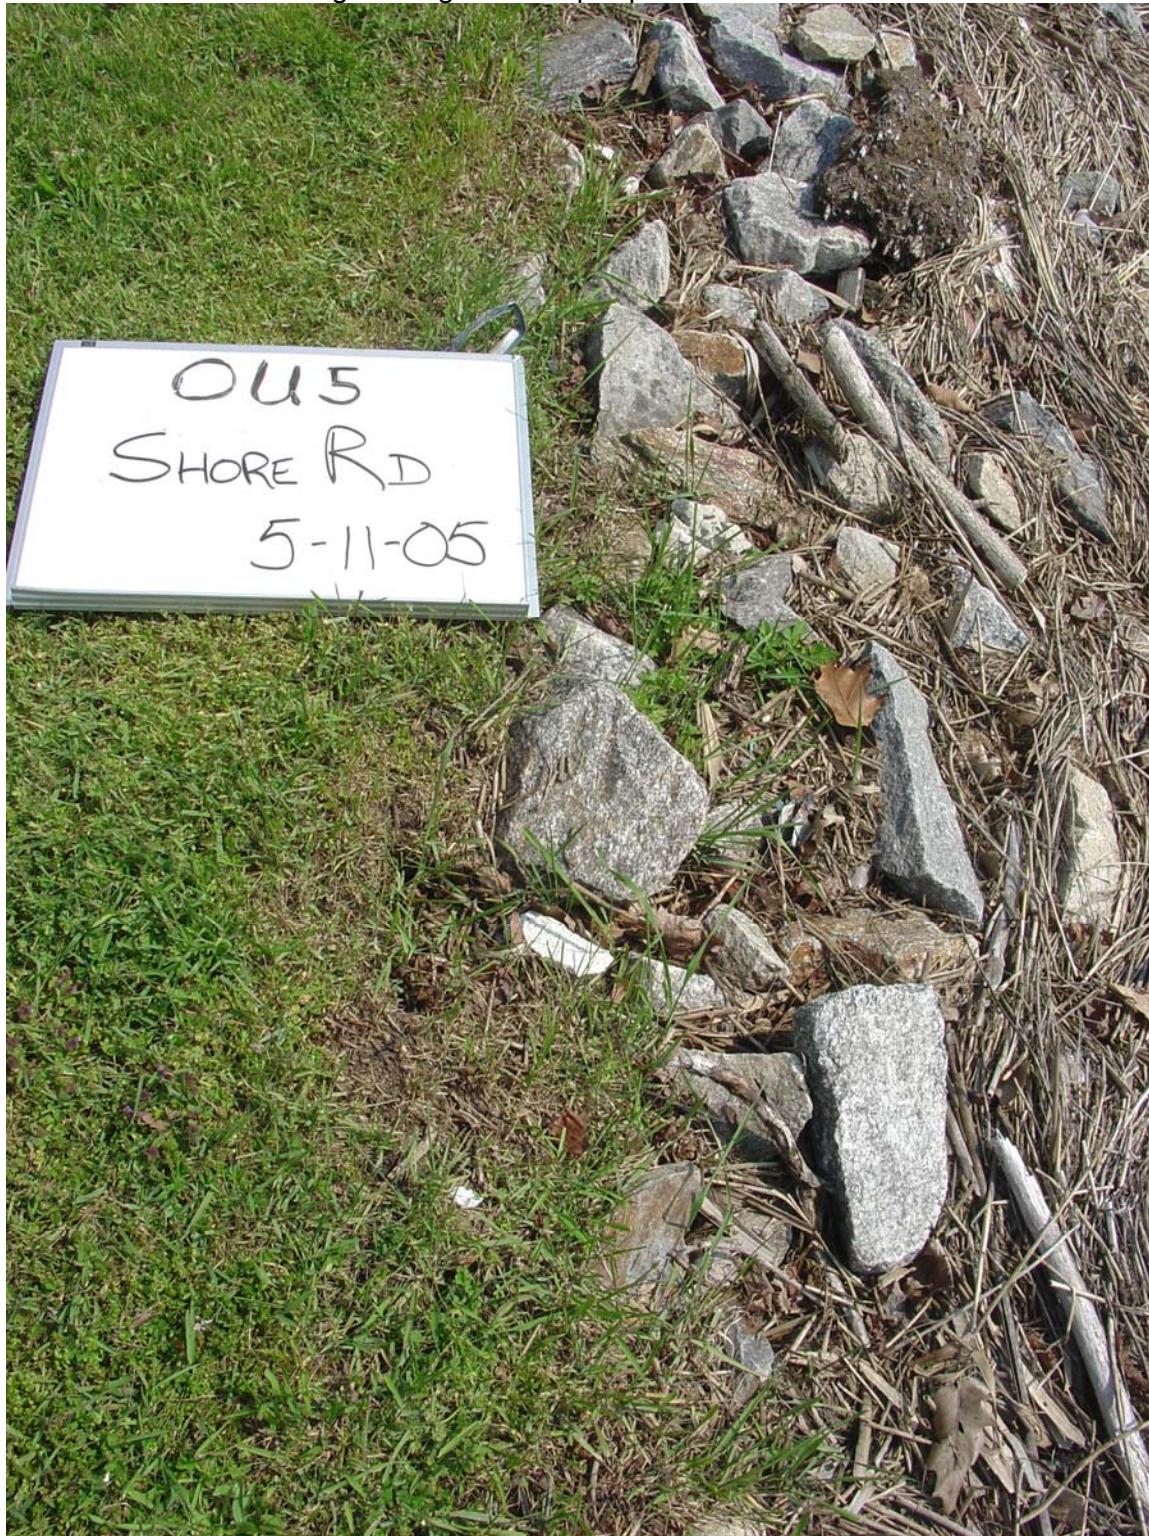
Some minor erosion along the edge of the rip-rap was noted as seen below

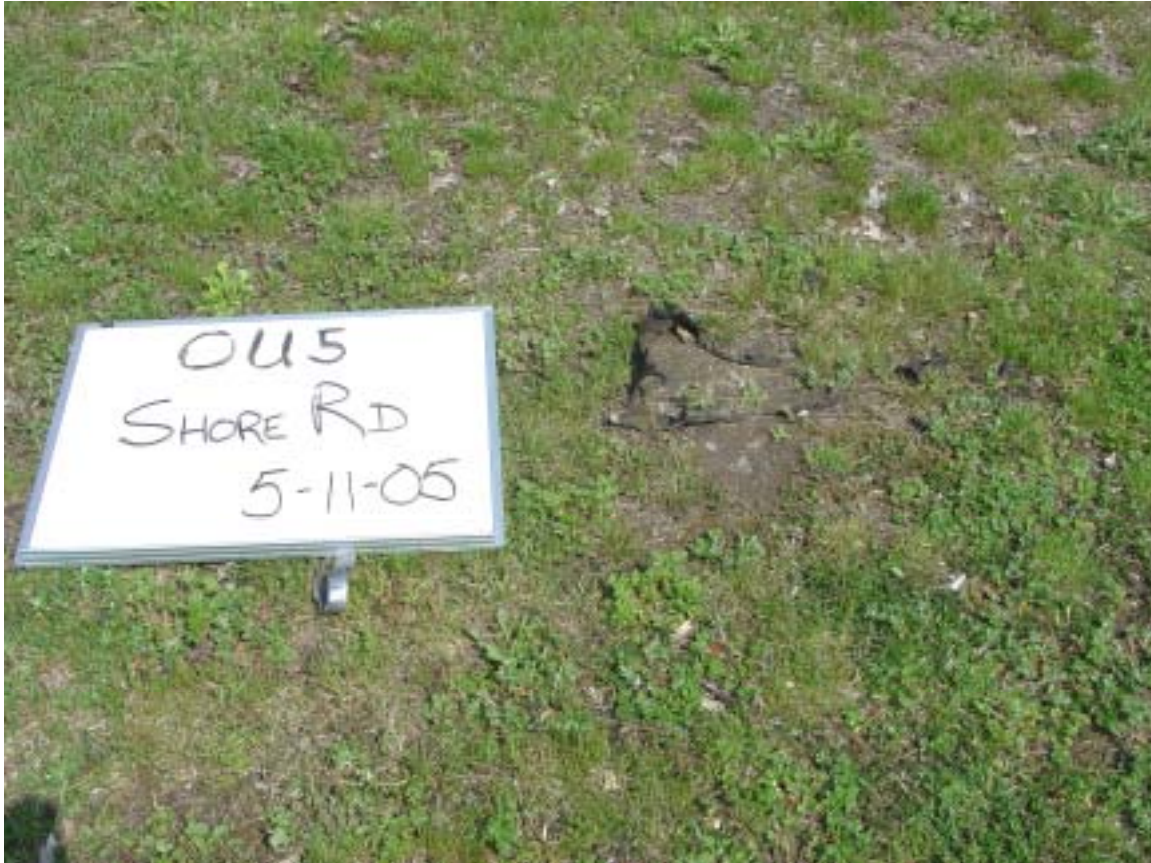
A small area of exposed and cut geotextile was noted on the lawn south of the boat club entrance drive.

1. Cracks in pavement should be sealed, especially along Shore Road.
2. Repair of monitoring well MW-532S and roadbox and monitoring well MW-530 should be made.
3. Geotextile repairs to the cover (south of the entrance to the boat club and along the concrete block retaining wall) and riprap repair (downstream of boat ramp structure) should be made.
4. Additional soil cover is needed for exposed areas south of the boat club entrance.
5. Settlement along the retaining wall and pavement should be regularly monitored for changes.
